# INSPECTOR GENERAL

JULY 18, 2013

## Compliance with Electrical and Fire Protection Standards of U.S. Controlled and Occupied Facilities in Afghanistan

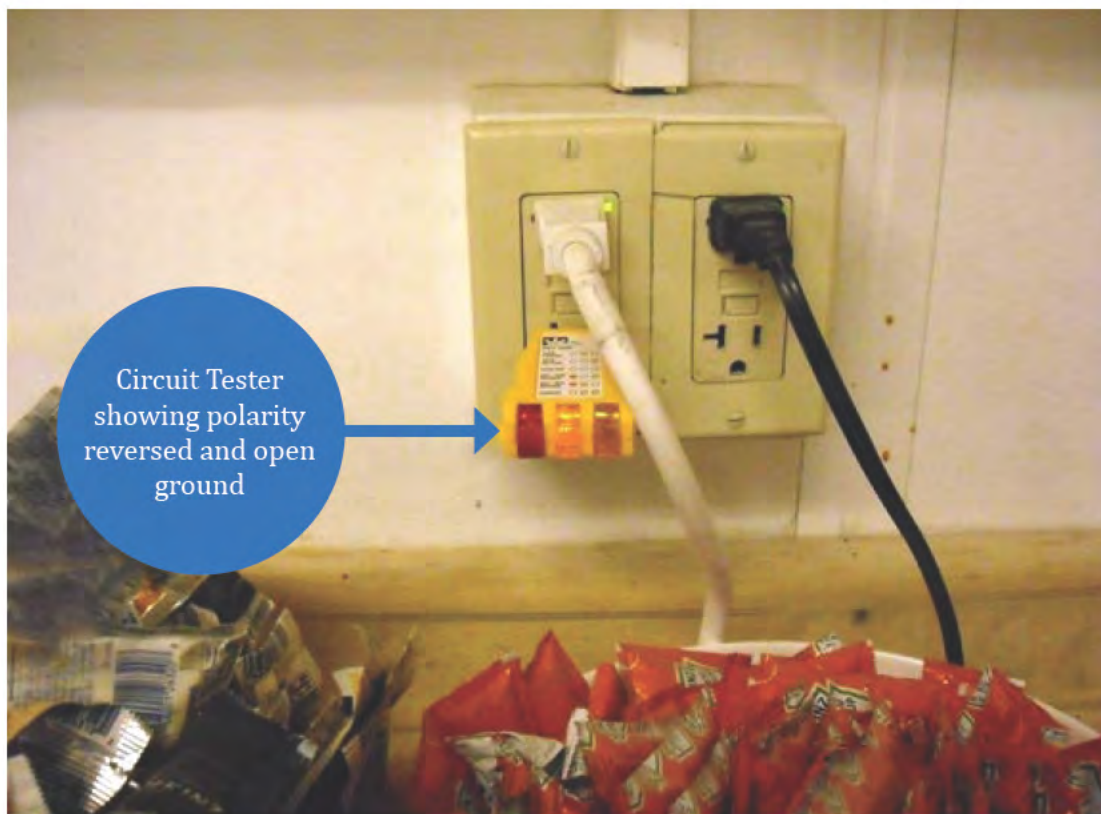
KAF-EL-120426-026

- In Building 518, reverse polarity and no grounding of kitchen receptacles: (Finding KAF-EL-120426-026)
- In Building 518, main electrical panel wires are not color-coded to any standard: (Finding KAF-EL-120426-025)
- In Building 156 “Old Kandahar Hotel,” live power cables placed directly on roof top: (Finding KAF-EL-120426-084)
- In Building 156 “Old Kandahar Hotel,” there are unprotected wires used throughout the living quarters: (Finding KAF-EL-120426-047)
- In Building RLB7B, living quarters are unsafe for occupancy due to severe wiring issues: (Finding KAF-EL-120426-097)

Figure 1. Reverse Polarity and No Grounding - Chaplain's Office Building Kitchen Area

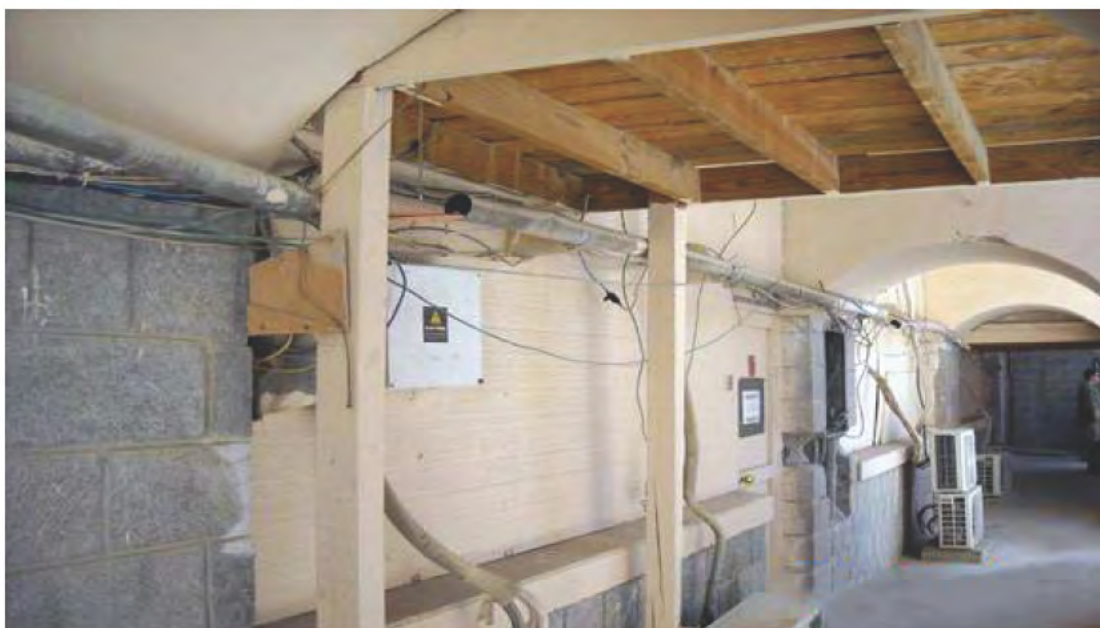
KAF-EL-120426-055

2. **Misuse of plastic-sheathed cables:** Multiple cases of indoor-rated, plastic-sheathed cables used in damp outdoor locations, unsupported and unprotected by conduit and raceways (Figures 2, 3, and 4). Improperly mounted cables and breaks in raceways increases the risk of abrasion and breaks in conductors, which could cause fire, electrical shock, and/or electrocution.

Figure 2. Noncontiguous Raceway in Outdoor Location

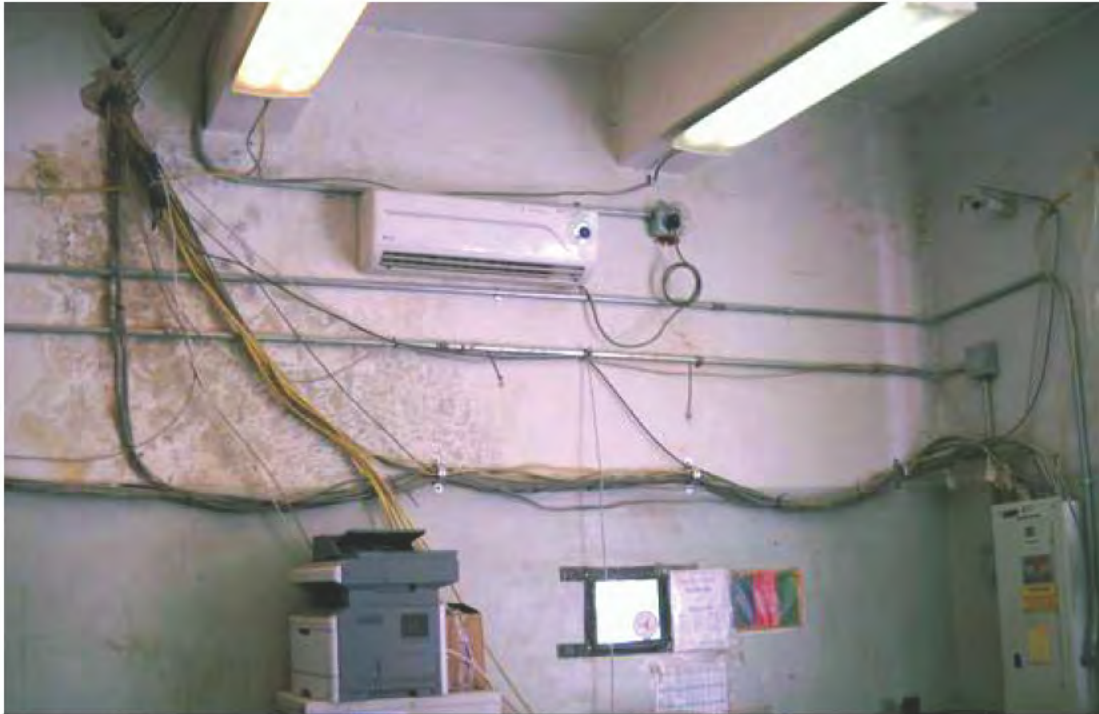
BAF-EL-120709-169  
Figure 3. Unsecured and Unprotected Cables – Main Post Exchange

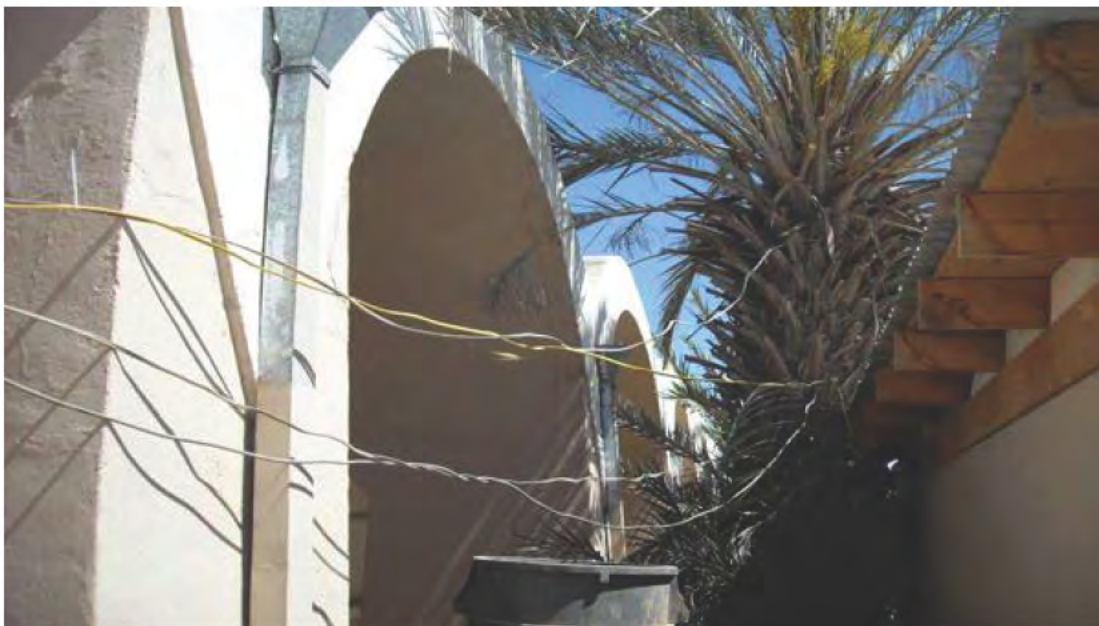
KAF-EL-120426-056B  
Figure 4. Outdoor Hazardous Service Drops to Living Quarters

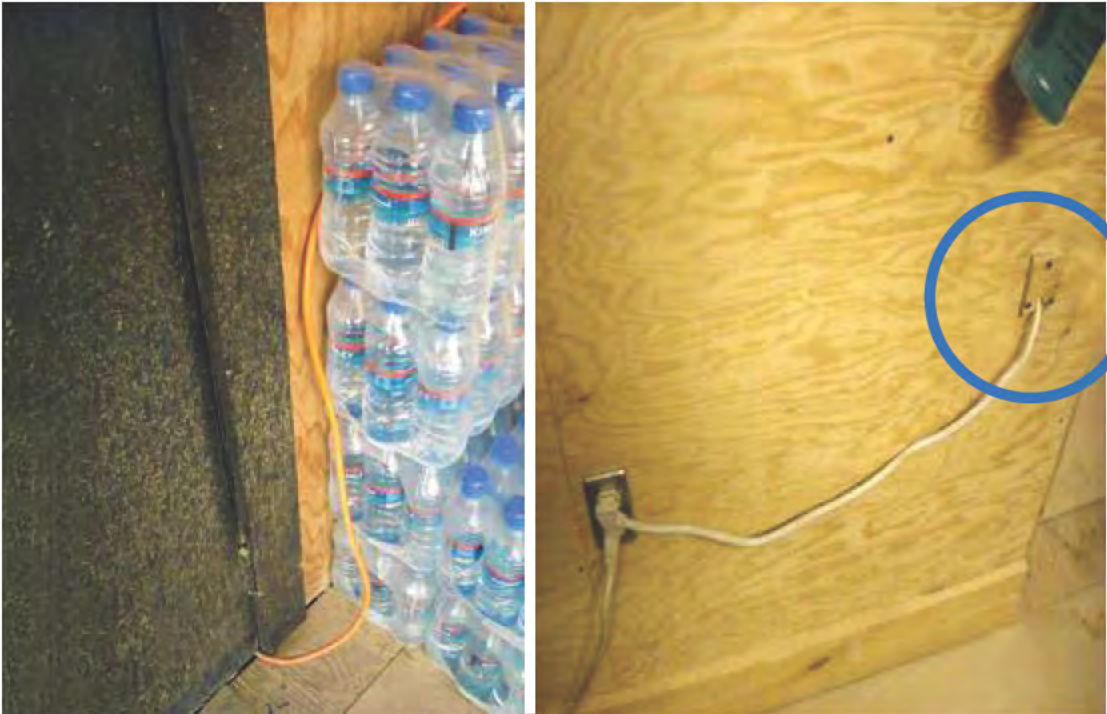
was significant. Extension cords used under these conditions are subject to damage and abrasion (figure 5). The use of an extension cord instead of fixed wiring creates the possibility of fire, electrical shock, and/or electrocution due to unprotected live conductors and overloading of circuitry.

KAF-EL-120426-072 (left)      KAF-EL-120426-087 (right)  
Figure 5. Extension Cords Used as Permanent Wiring Run Through Doorways and Walls – Office Building

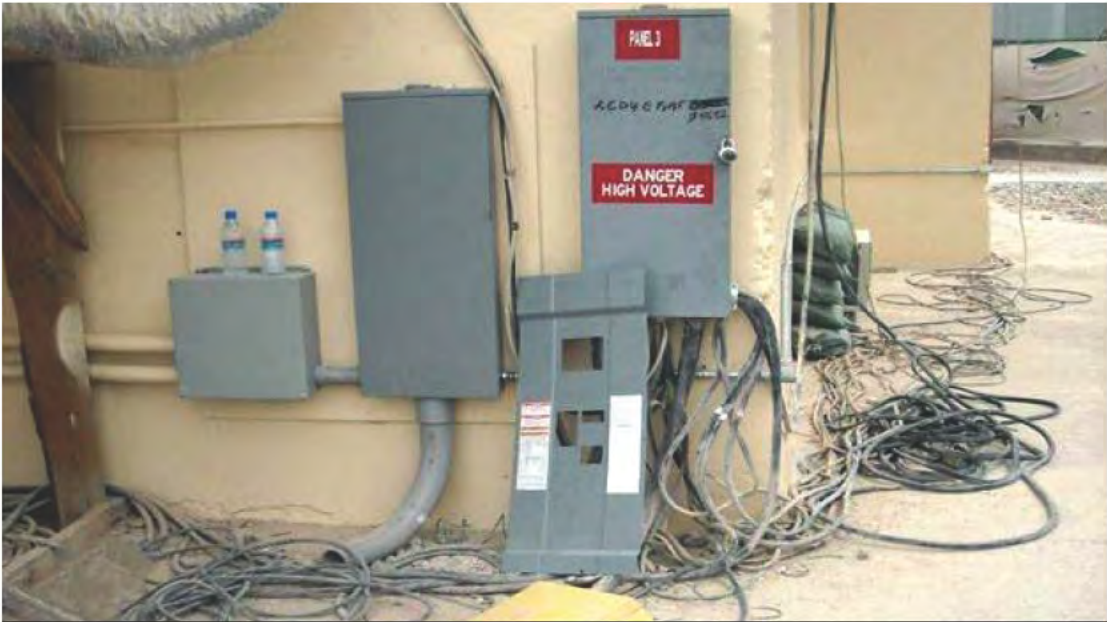
4. **Hazardous electrical service to facilities:** Electrical wires supported by rooftops, many cases of incomplete or damaged electrical panels, and electrical panels that are missing front covers and other covers for openings (Figures 6, 7, 8 and 9). Power lines draped over the top of buildings and structures present a high risk for fire and electrocution. Energized panel enclosures with front covers that do not fit properly expose energized wires, increasing the risk of electrocution to personnel accessing the circuit breakers. Also, damaged electrical panels present the possibility of other unseen internal damage and could result in ground faults/arc flash and potential fire, electrical shock, and/or electrocution.

KAF-EL-120426-075  
Figure 6. Hazardous Workmanship

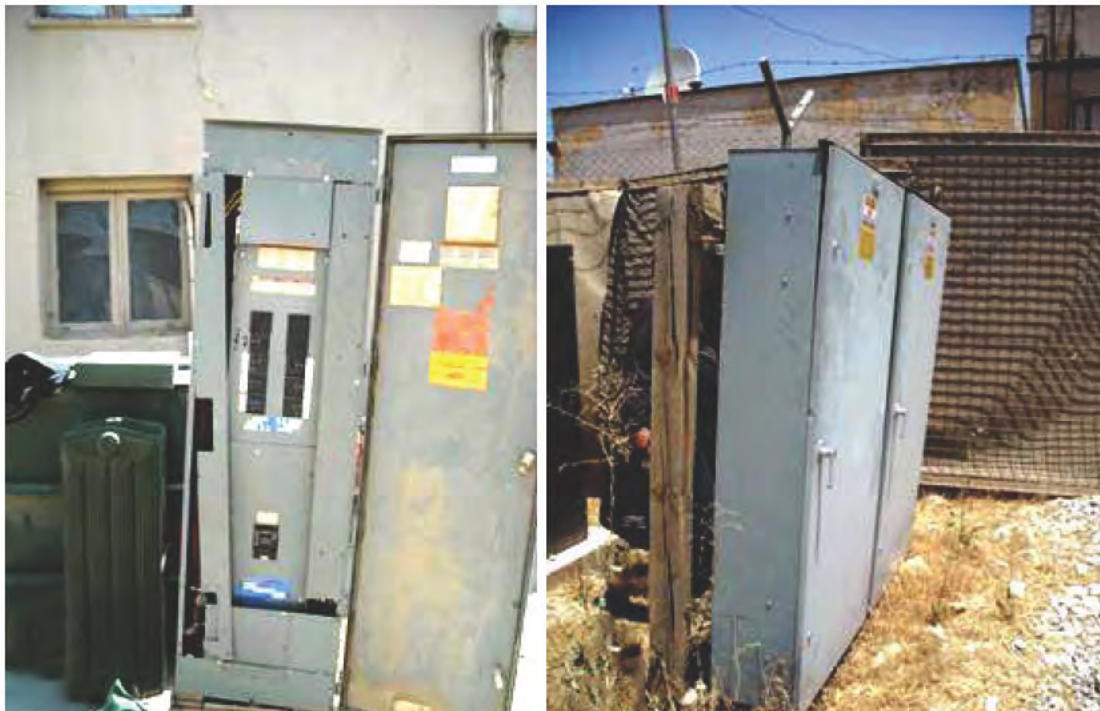
BAF-EL-120709-017 (left)    BAF-EL-120709-063 (right)  
Figure 7. Damaged and Hazardous Electrical Panels

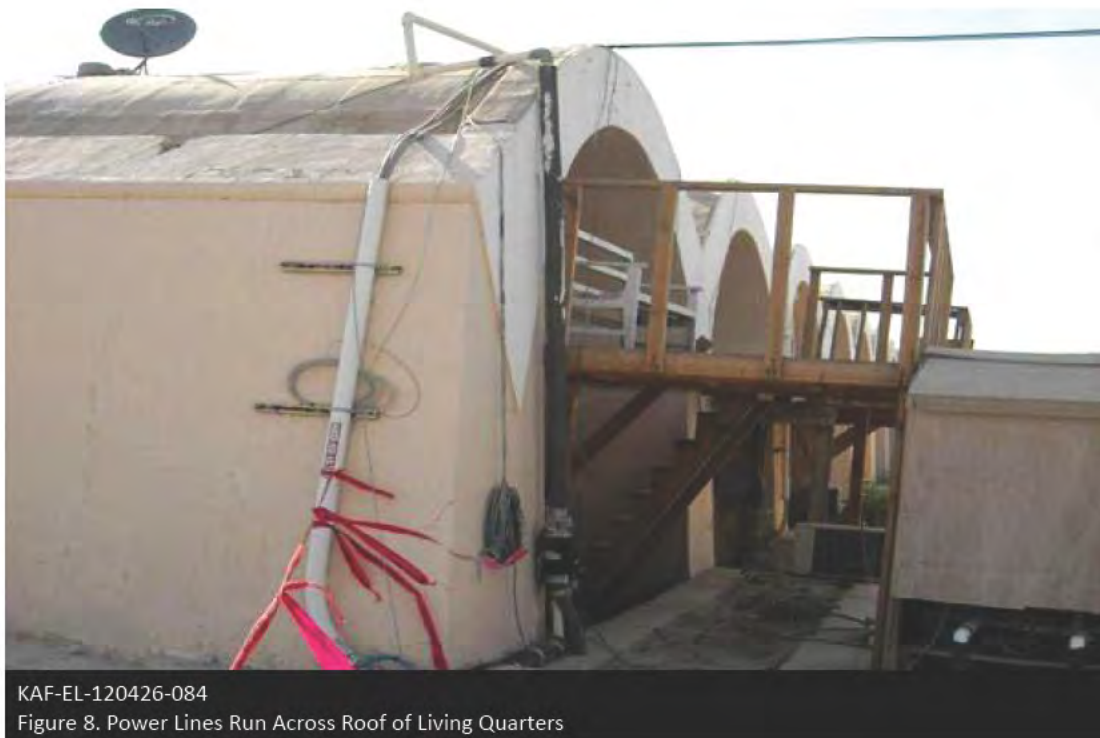
KAF-EL-120426-084  
Figure 8. Power Lines Run Across Roof of Living Quarters

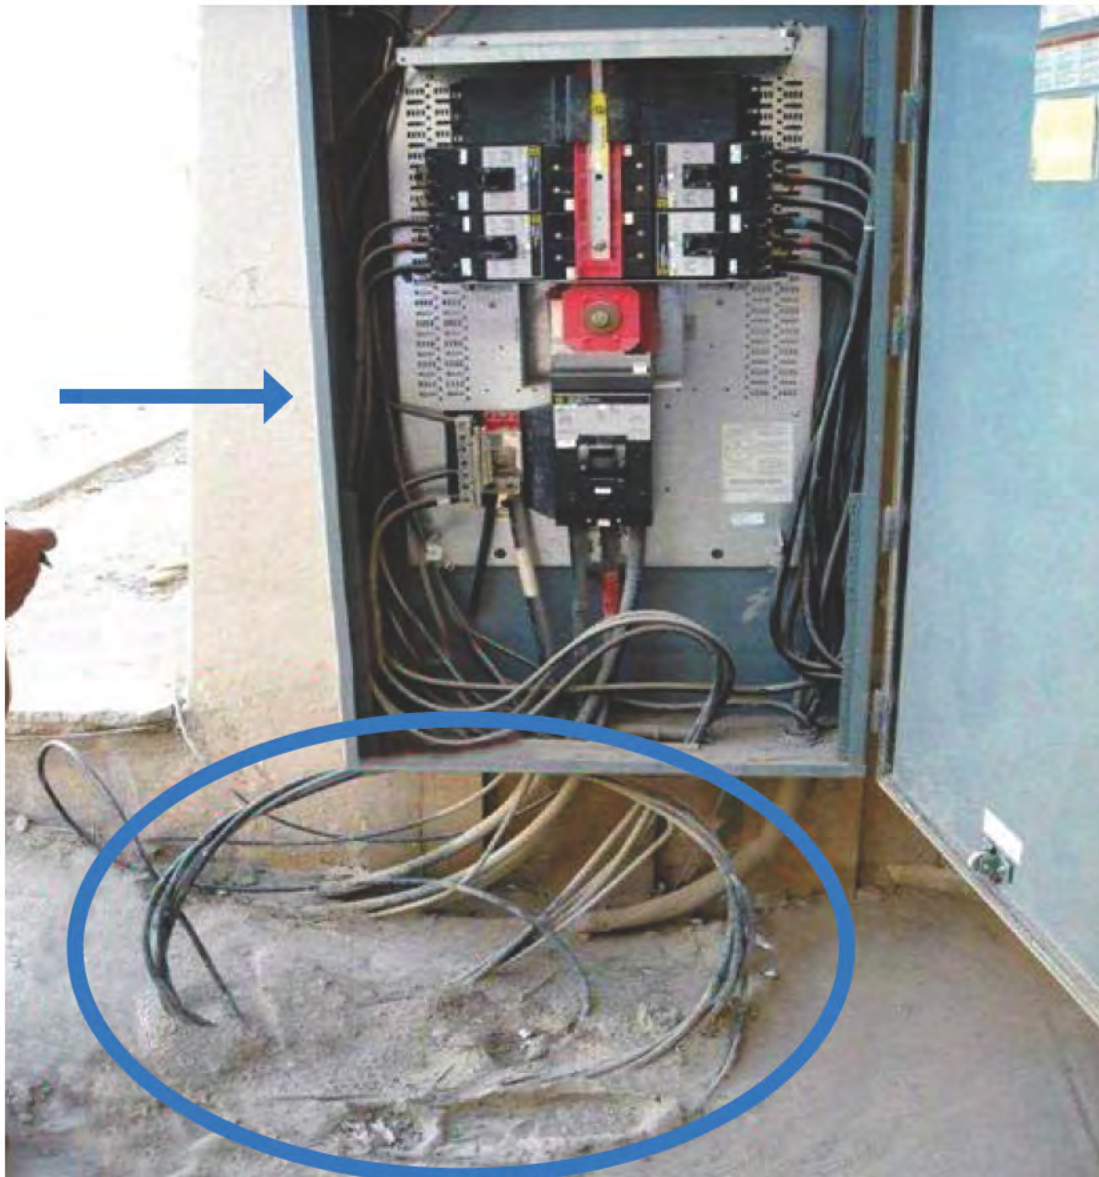
KAF-EL-120426-057

Figure 9. Unprotected Cables Buried in Concrete (Circled) and Missing Front Panel Covers

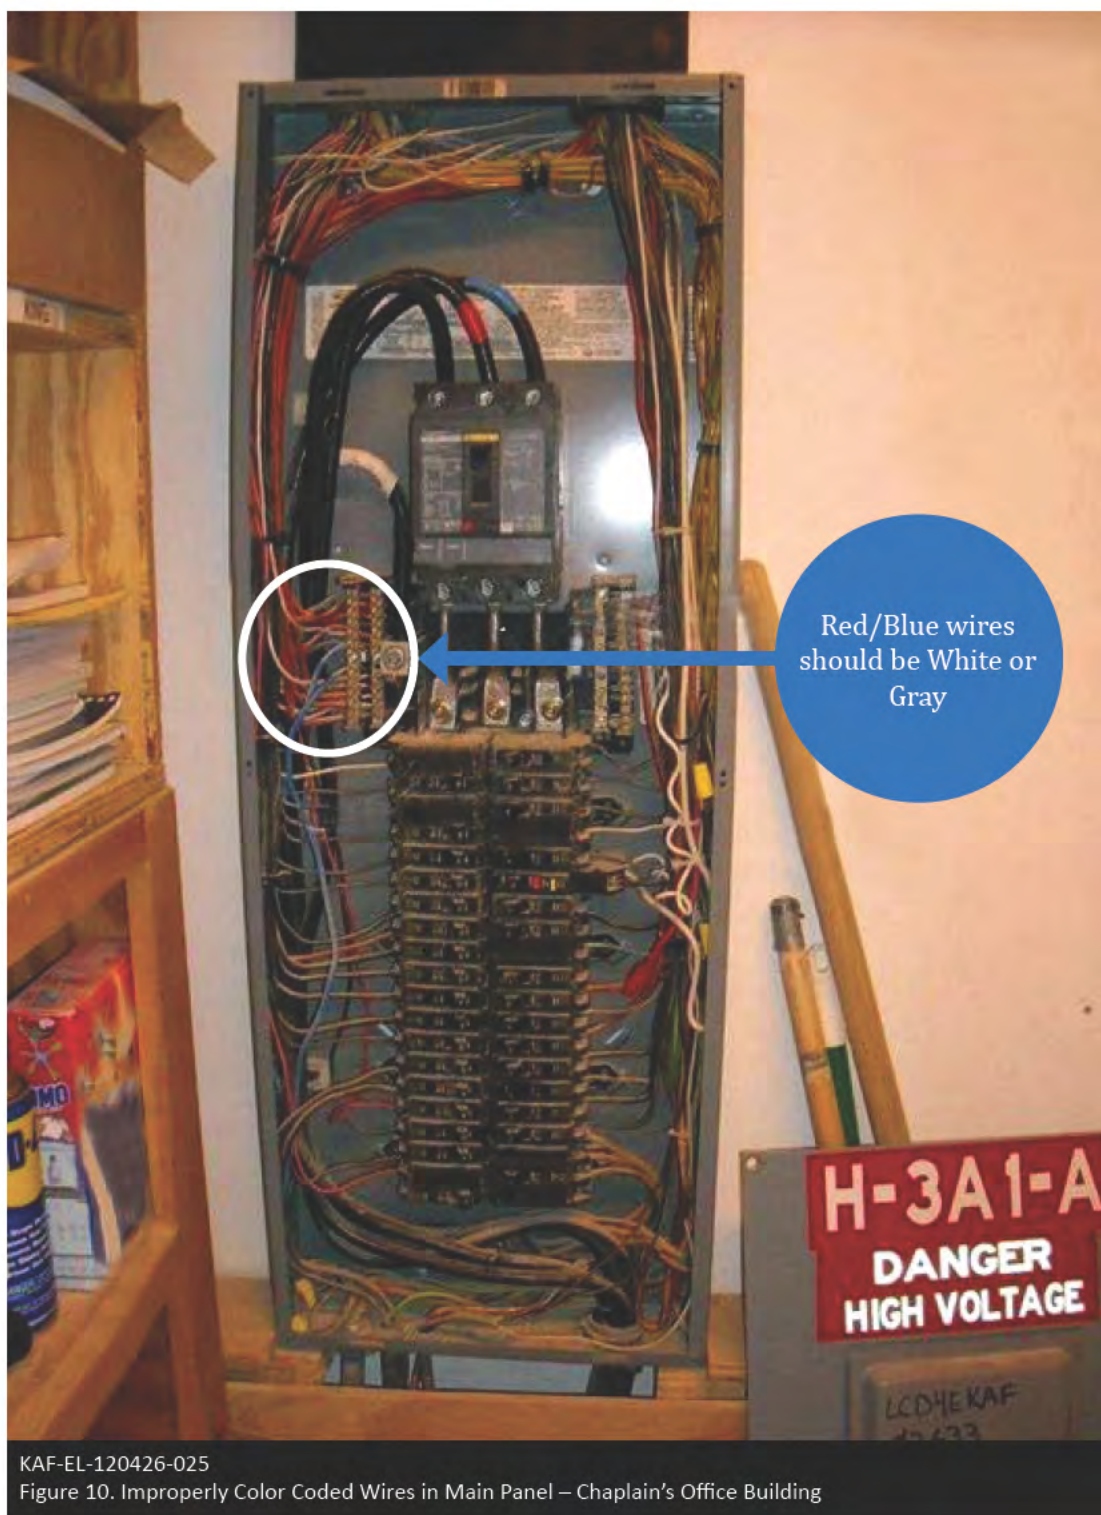
KAF-EL-120426-025

6. **Other:** Non-systemic issues include the lack of an automatic charging system for the fire pump house water pump engines, nonoperational hospital standby/backup power system, improper color coding of electrical wires (Figure 10), and electrical receptacles filled with paint.

Figure 10. Improperly Color Coded Wires in Main Panel – Chaplain's Office Building

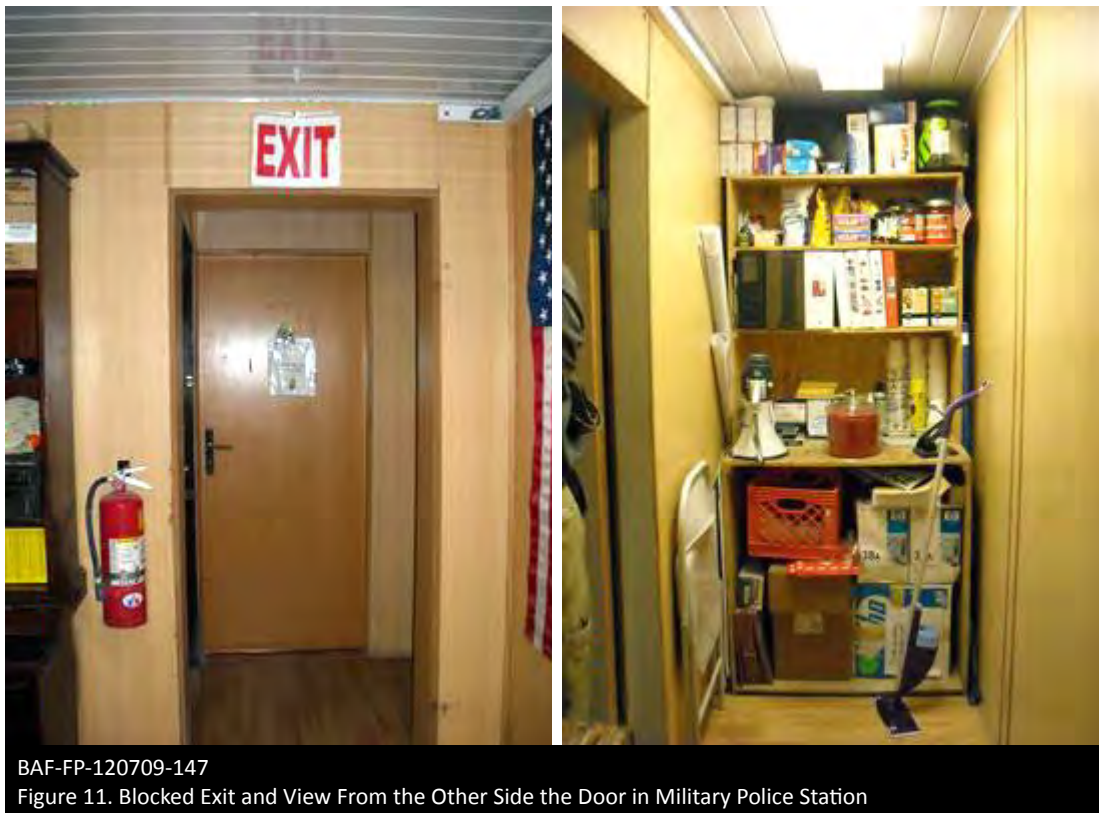
1. **Means of egress:** Locked and obstructed exits and inadequate exit configurations, signage, and emergency lighting. Many cases where the exits are locked, obstructed (Figure 11) or not clearly identified in all lighting levels; occupants may become confused or even trapped by not being able to readily locate the exit during an emergency.

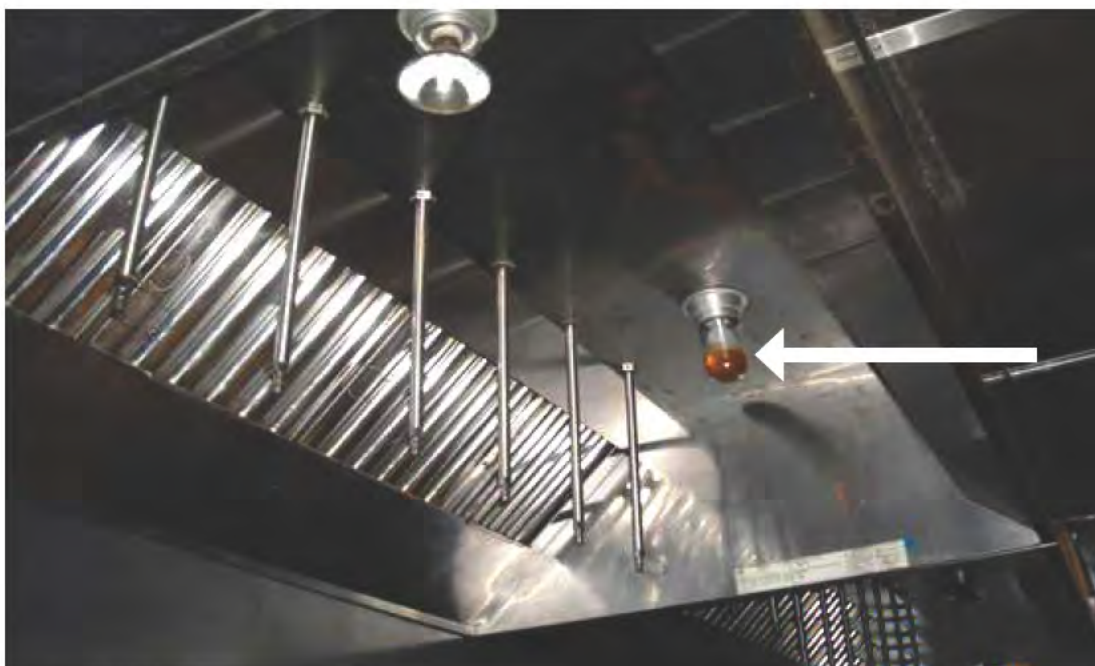
BAF-FP-120709-333

2. **Fire suppression:** Lack of sprinkler systems, and fire sprinkler pump houses that are nonfunctional or not maintained. This is significant as fire sprinklers are the most effective means of controlling a fire in the incipient stages and reducing the risk of injury or loss of life. Also includes kitchen hood extinguishers that are nonfunctional or not maintained (Figure 12). Kitchens have deep fryers and cooking equipment that produce grease-laden vapors. Failure to maintain a functional fire suppression system for kitchen cooking equipment results in an increased risk of fire and a significant risk of fire spreading rapidly throughout the facility.

Figure 12. Nonfunctional Kitchen Fume Hood Fire Suppression Systems  
(Note Flammable Grease in Light Fixture)

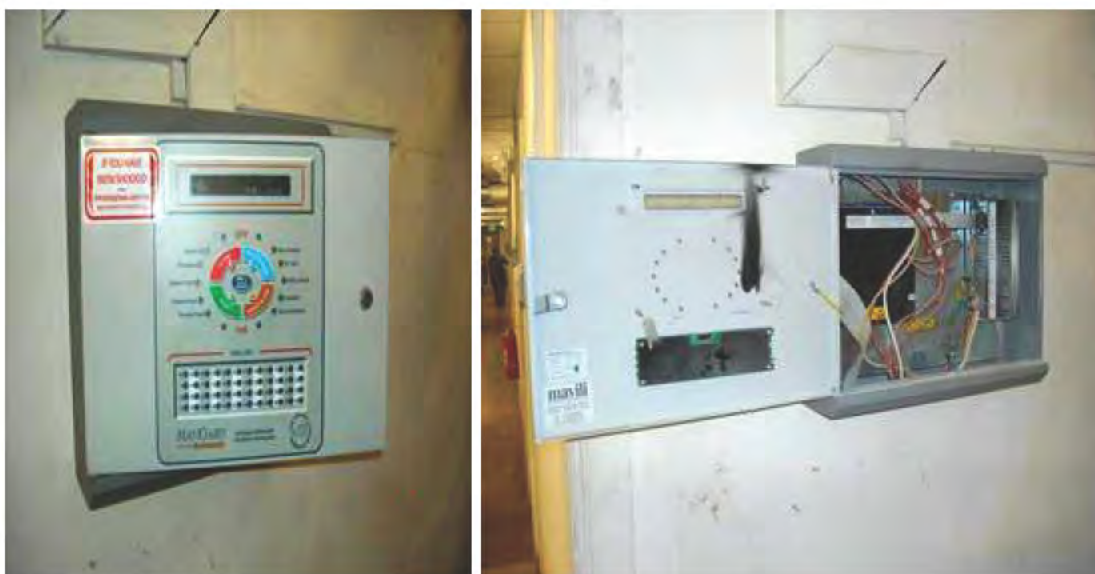
BAF-FP-120709-244

Figure 13. Inoperable Fire Alarm Systems In Living Quarters  
Closed and Opened - Burned Out with Internal Control Panel Removed

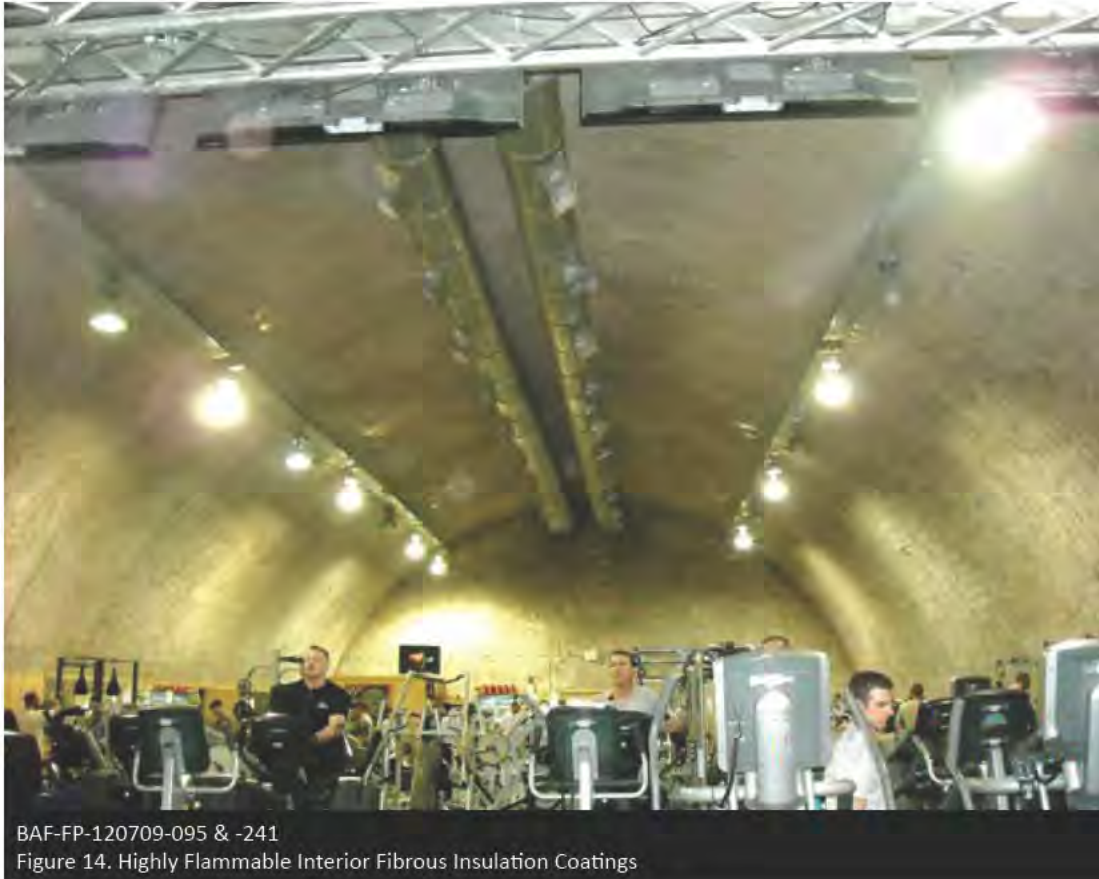
5. **Construction-passive protection:** Lack of firewalls in sleeping areas, inadequate exit protection, and combustible materials (Figure 14). The systemic use of combustible materials in sleeping areas creates an increased risk of fire, which could lead to the loss of life and mission-critical assets.
